Title: Pigg River Water Quality Analysis – Years 2020-2021.

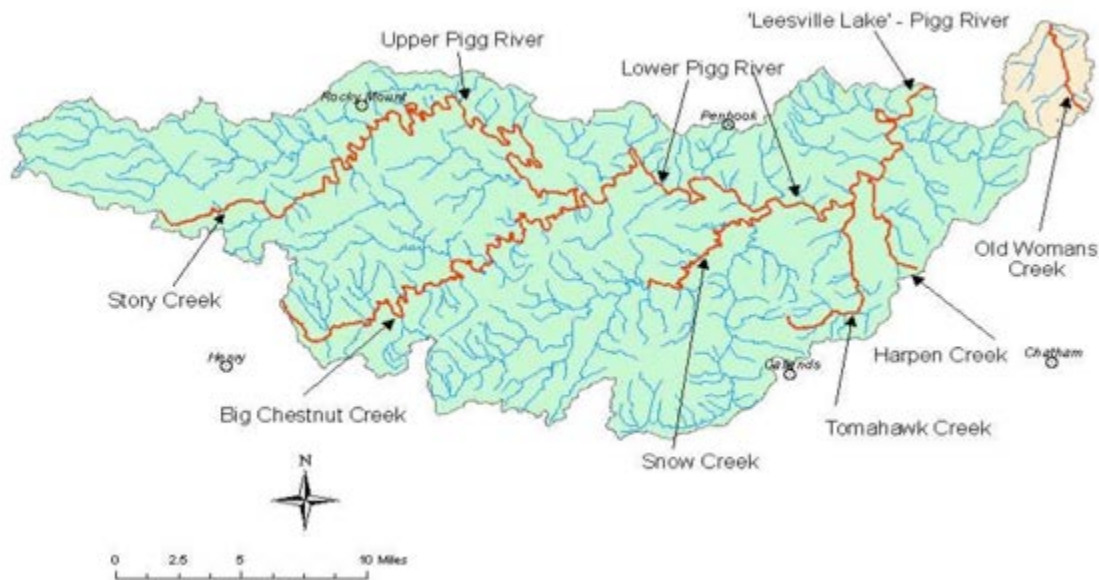
Figure 1 – Map of Pigg River Watershed. Samples were collected throughout the watershed including Lower Pigg (All Portions of the River

below Rocky Mount and Upper Pigg (All Portions of the River above Rocky Mount). We eliminated sampling on Snow Creek and Big Chestnut Creek based on earlier sampling (Figure from Virginia Tech 2006).

We sampled 11 sites along the Pigg River and its associated tributaries (Figure 1). In 2020, we focused on the upper Pigg River characterizing any associated problems emanating from Rocky Mount. In 2021, we focused on the lower Pigg River looking at areas suspected as having significant agricultural inputs.

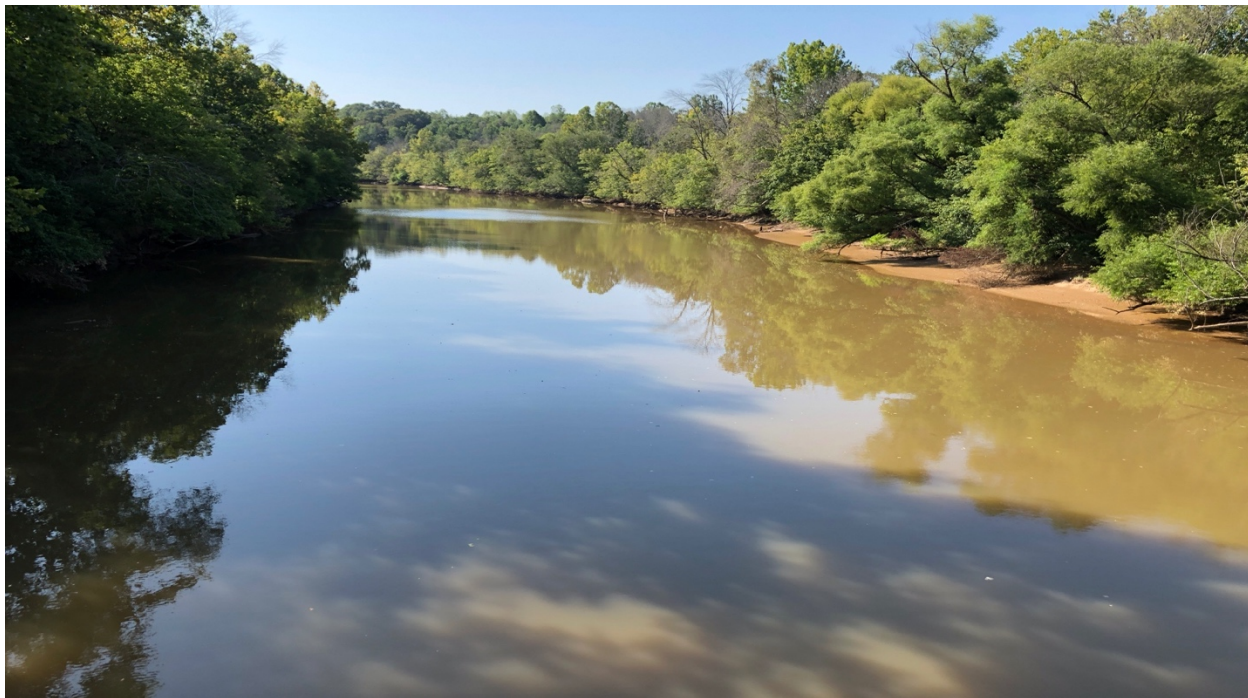
Figure 2 – The Pigg River as it enters Leesville Lake showing the excessive turbidity present during storm events. This is the Toshes site (Figure by permission of author).

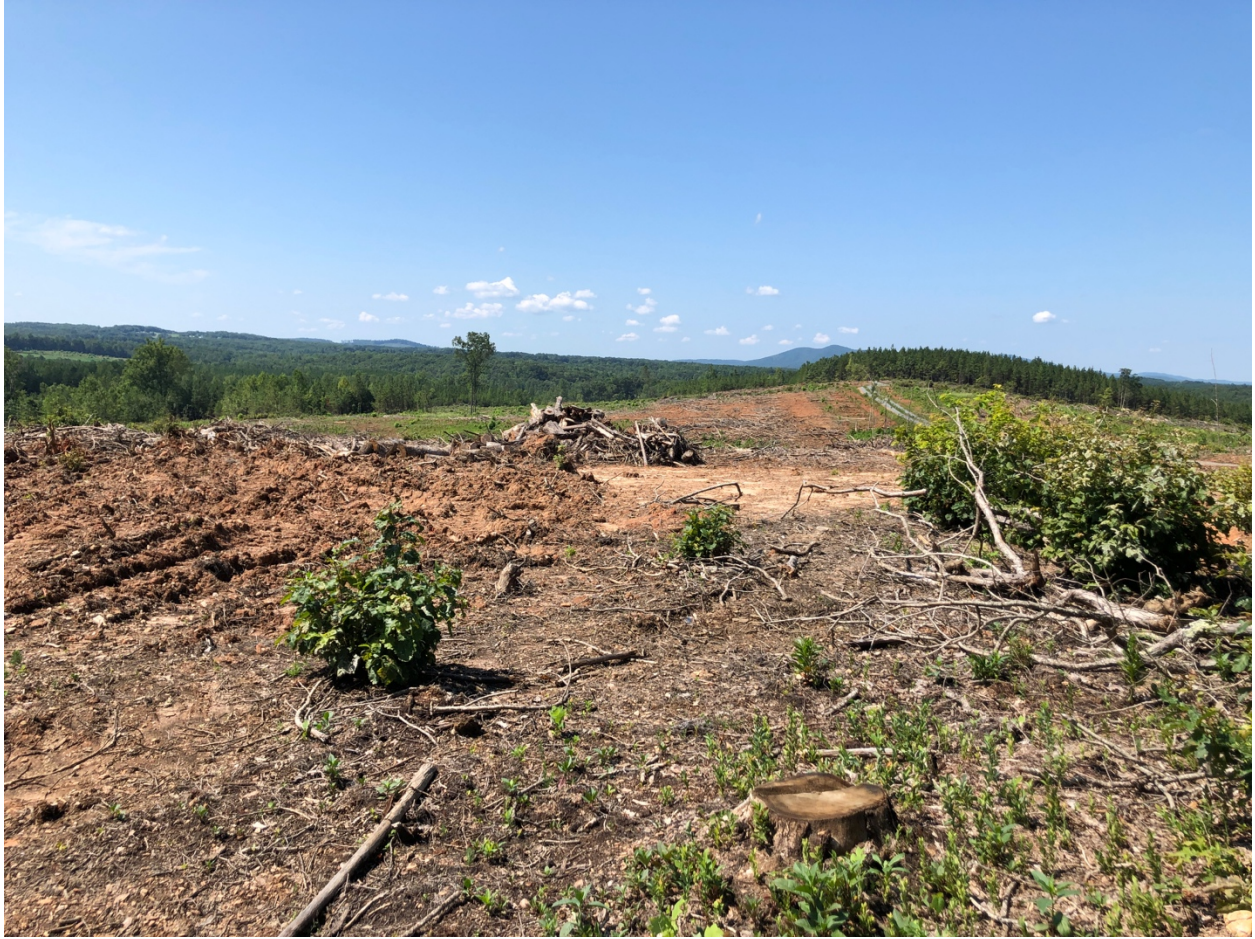
Figure 3 – Area of recent deforestation in the Pigg River Watershed. This is occurring throughout the watershed (Figure by permission from Author).

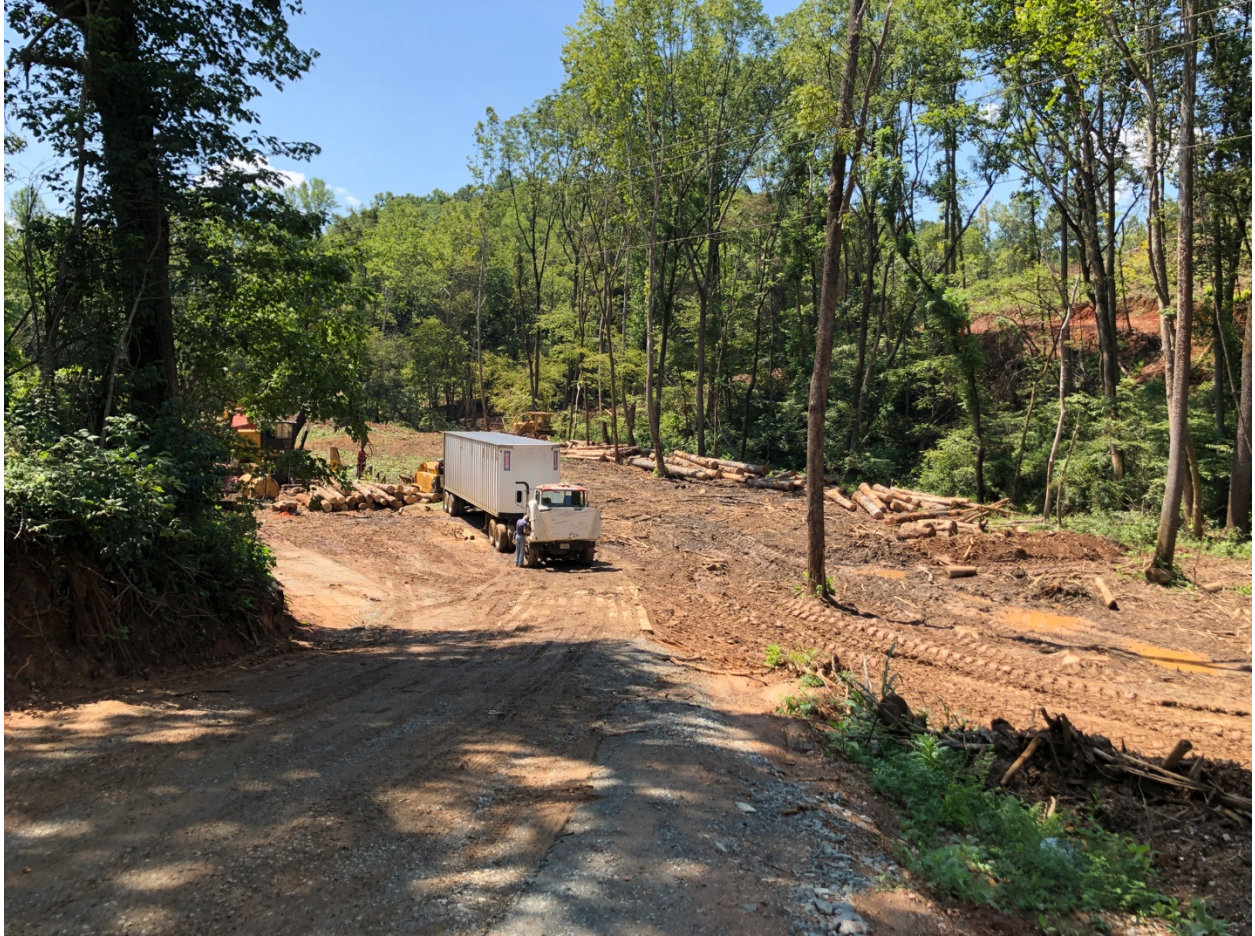
Figure 4 – Area of active deforestation along the banks of the Pigg River. This activity is within the riparian corridor of the river and is adjacent to the Museville sampling site (Figure by permission from Author).

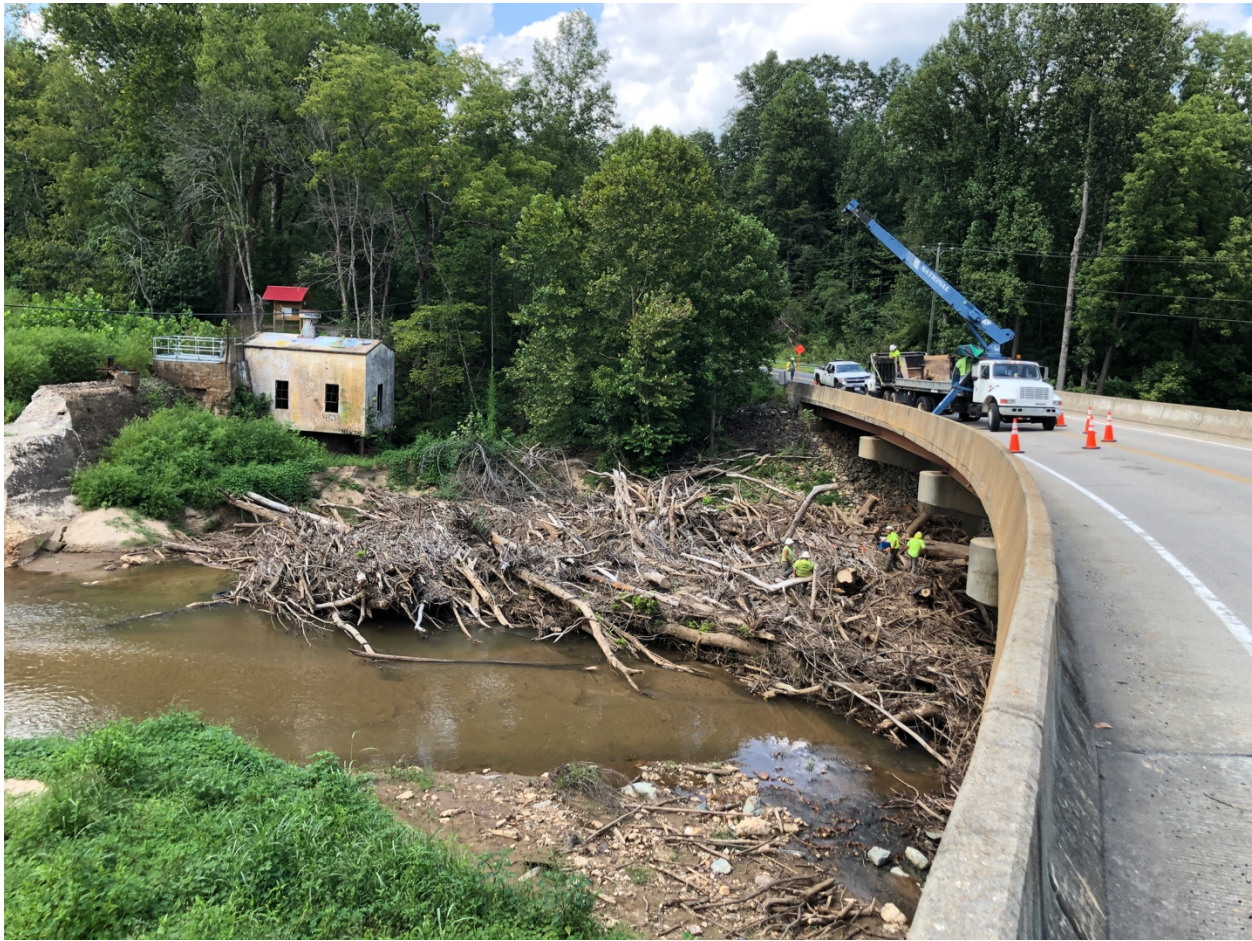
Figure 5 – Excessive buildup of timber from deforestation into bridge on Power Dam Road near Rocky Mount Virginia. Contractors are working to remove the debris (Figure by permission from Author).

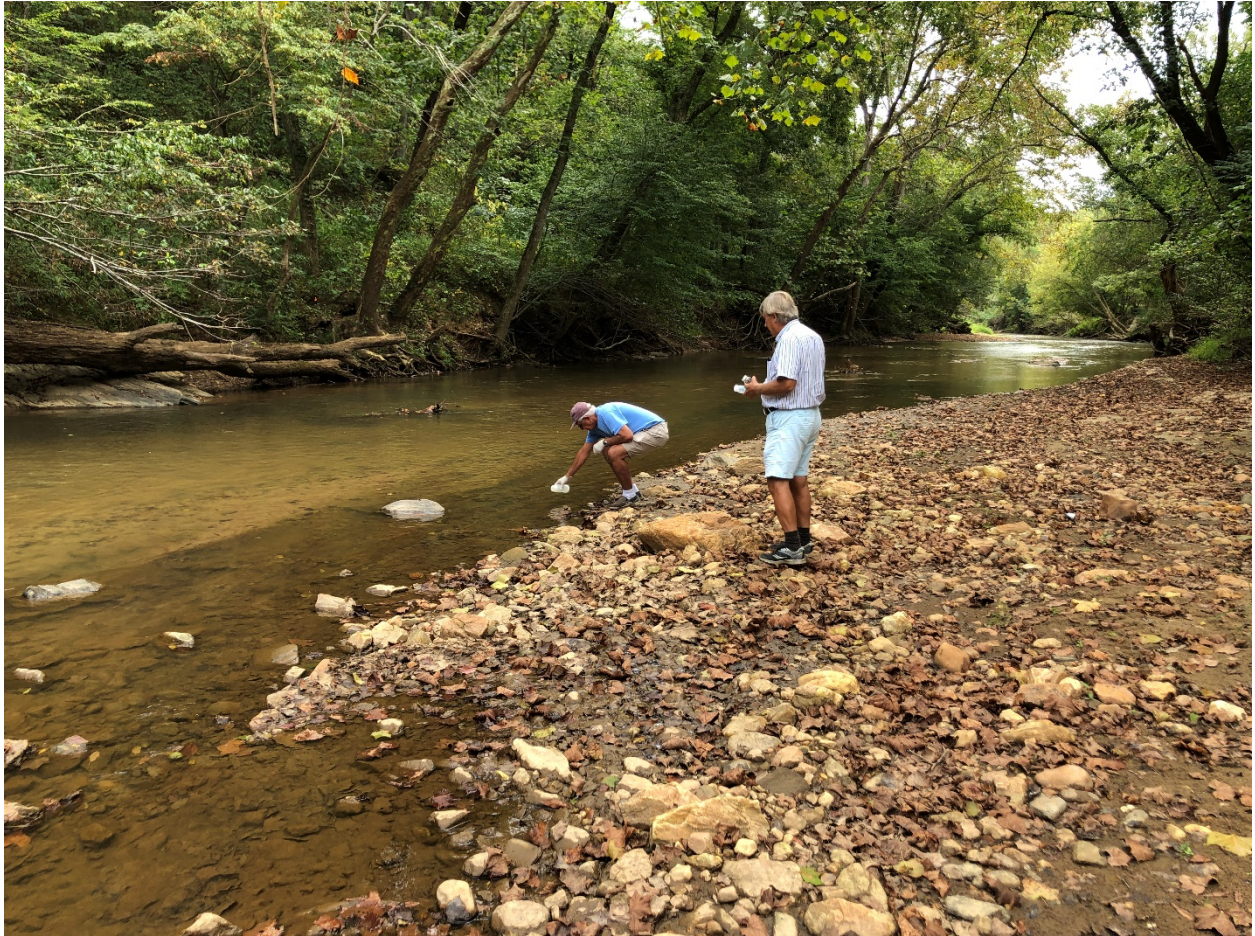
Figure 6 - Sampling the Pigg River at Chestnut Hill Road crossing during a dry period for Bacterial Source Tracking (Figure by permission from Author).

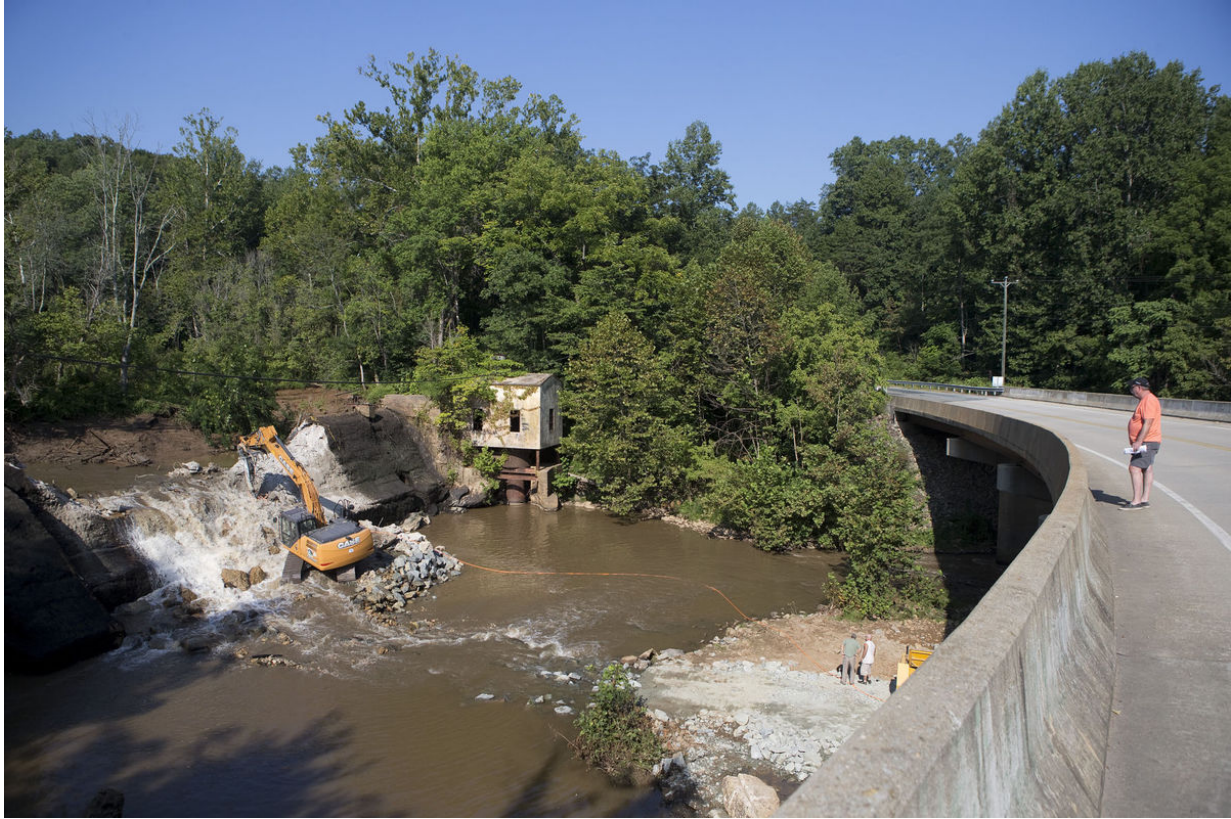
Figure 7 – Removal of the Power Dam. This has created an ongoing concern about water quality in the Pigg River (Figure from review by D. Orth <http://vtichthyology.blogspot.com/2017/11/trends-in-dam-removal-reversing.html>).

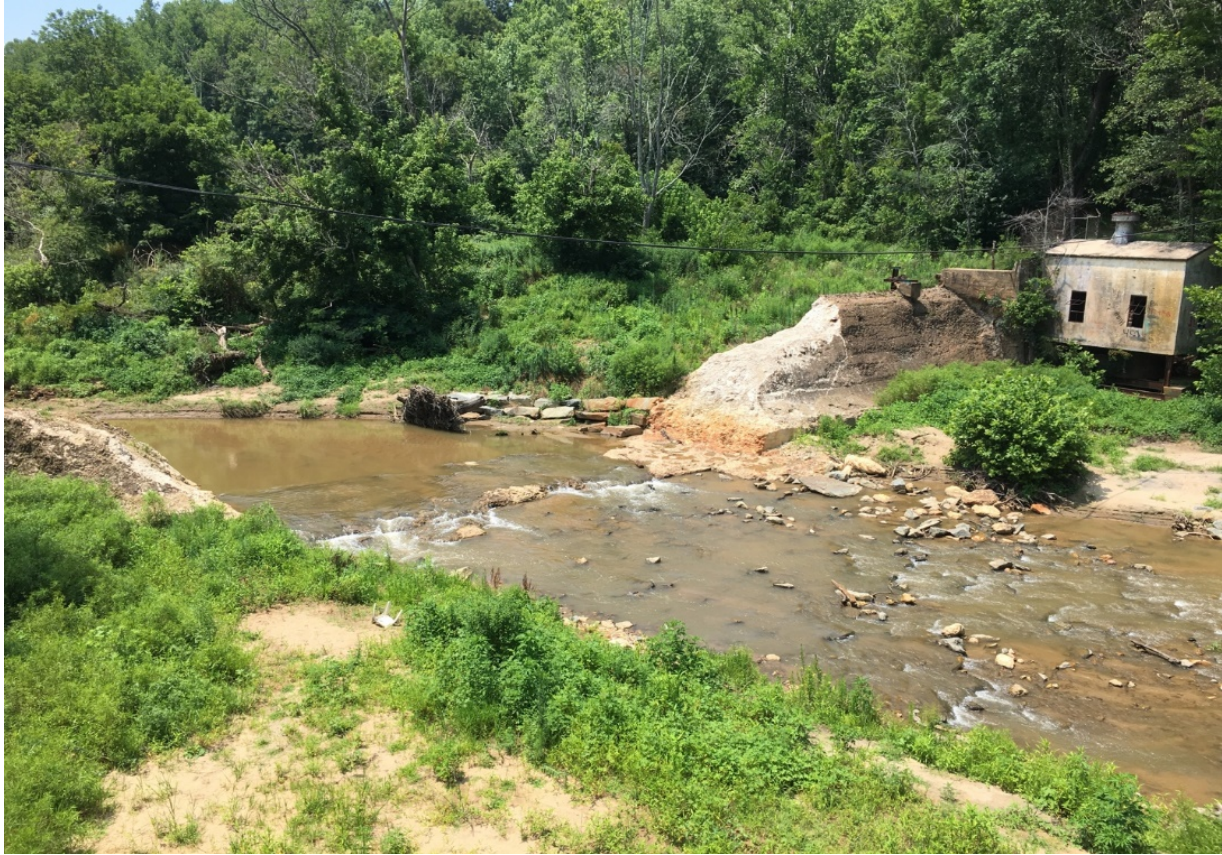
Figure 8- late summer condition of dam on Power Dam Road after removal. Legacy sediment appear to be a continual problem. Note the discoloration of the water even during low flow conditions (Figure by permission from Author).

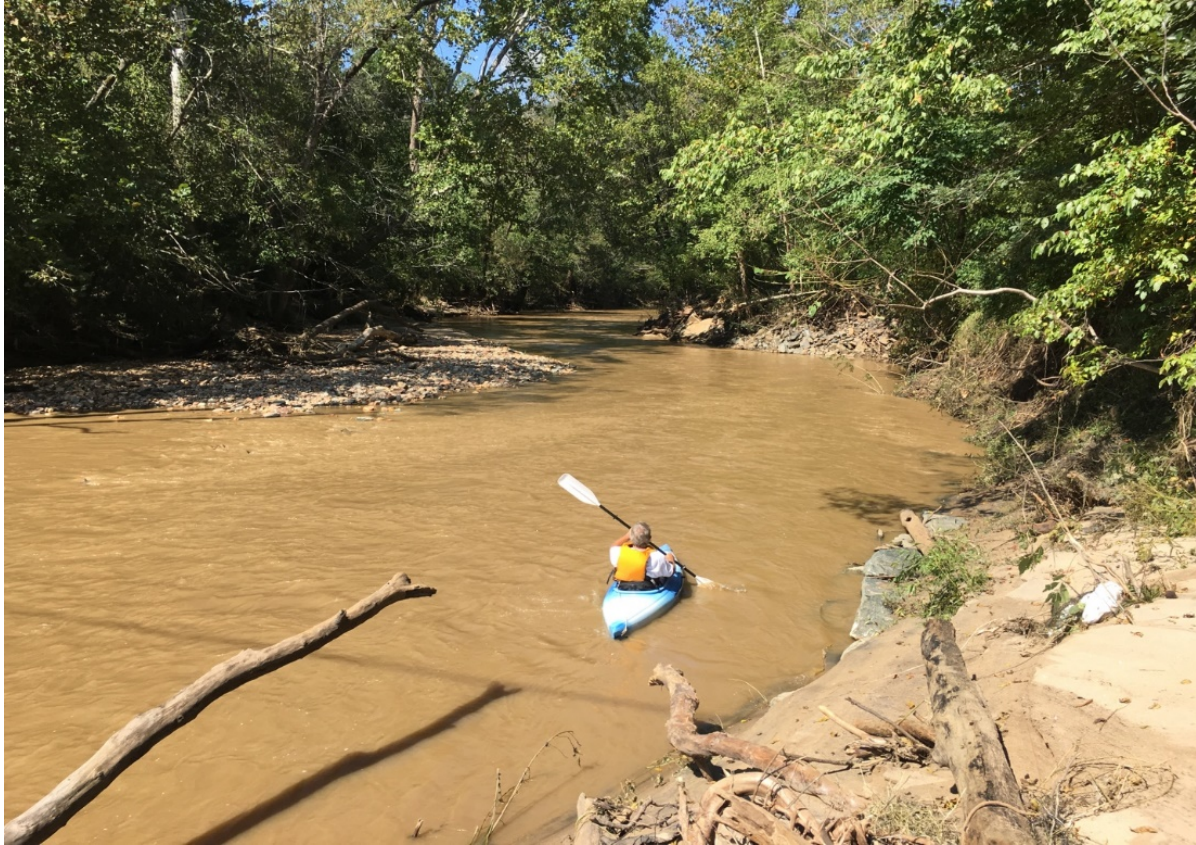
Figure 9 – Sampling the Pigg River by kayak following one of the storm events in early fall. Note the color of the water. This sampling method allowed direct measure of WWTP effluent (Figure by permission from Author).

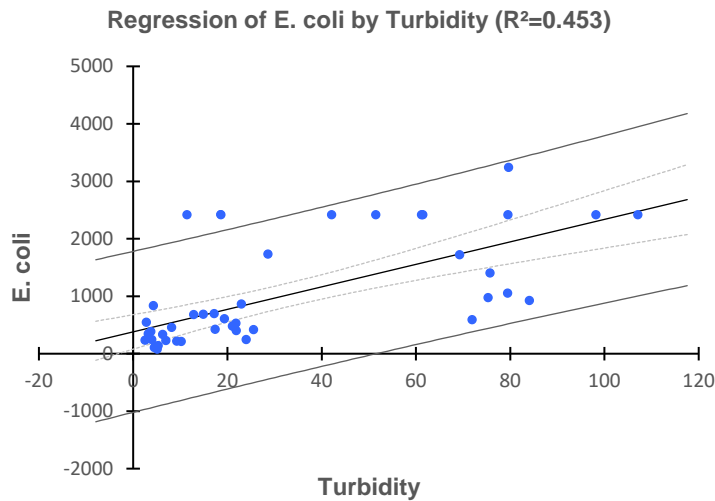
Figure 10 – regression of turbidity and *E. coli*. The relationship is highly significant ($p<0.001$). Lines represent 95% confidence interval.

Yet, stormwater is very concerning. The data presented here demonstrate that under elevated flow conditions *E. coli* and Total Phosphorus (TP) elevate quickly. This highly contaminated water flows through the Pigg River eventually enters Leesville Lake, contributing to water quality problems in this system. We have established a significant relationship between turbidity and *E. coli* in this river (Figure 10), and also between

- Both elevated *E. coli* and TP concentrations strongly correlated with turbidity. Increasing turbidity generates increased concentrations of pollutants of concern.
- Turbidity increases with increased flow in the river. This is associated with precipitation. Under baseflow conditions, we do not see elevated turbidity nor concerning levels of any pollutants.
