## **LVL Water Quality Update for Spring 2020**

Interim Report  
Leesville Lake Water Quality Monitoring  
Submitted to Leesville Lake Association  
June 1, 2020

Thomas Shahady, Ph.D.  
University of Lynchburg

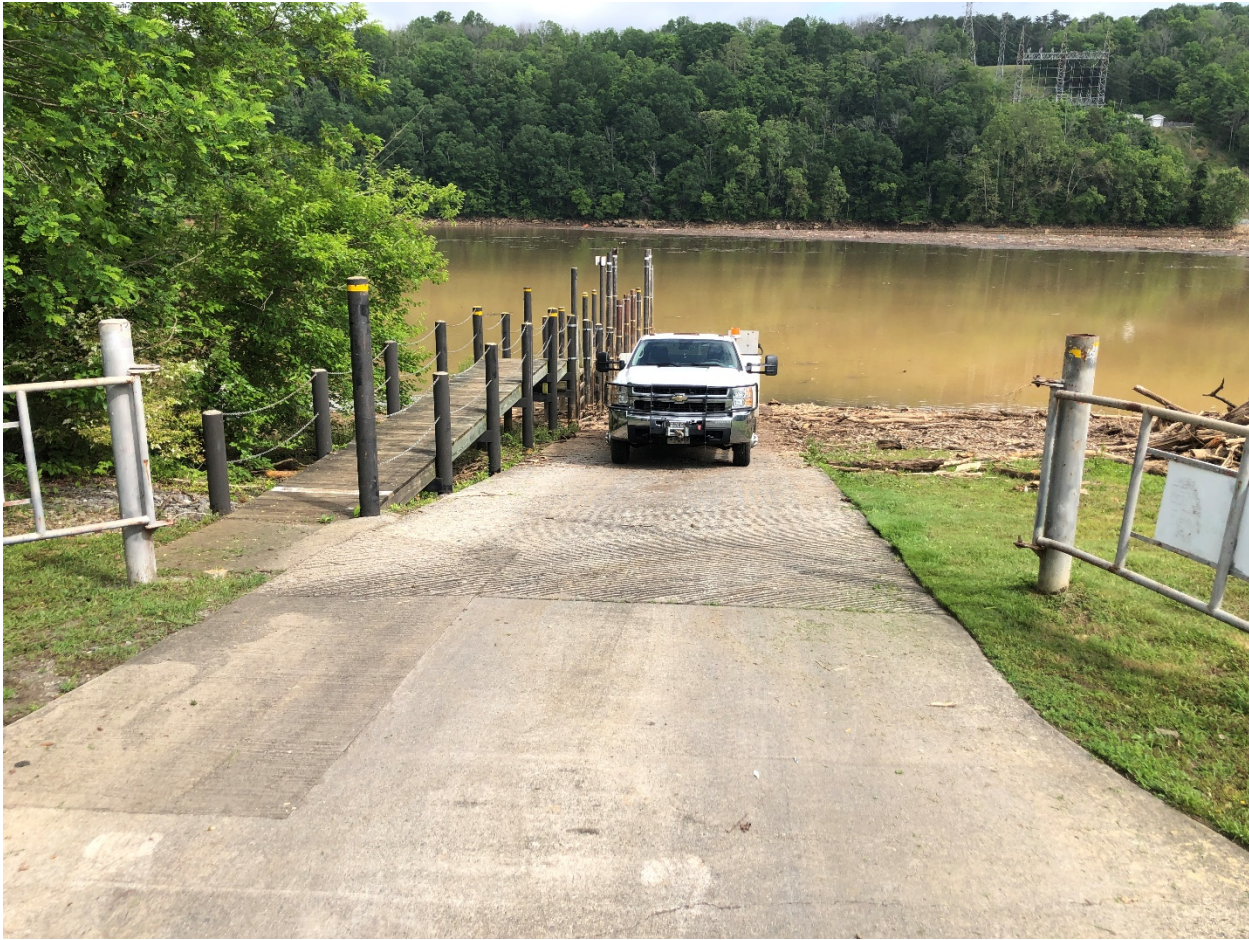
Initial observations of Leesville Lake on May 29, 2020 were the very low water level (near 602 feet) and the amount of debris that had accumulated around the boat launch at the dam (Figure 1). The condition of the lake apparently caused AEP to park a truck on the ramp and declare the ramp “closed.” Additionally, water at the dam was very turbid for this region of the lake, appearing brown in Figure 1.

Figure 1 – Virginia Department of Games and Inland Fisheries boat ramp at Leesville Lake Dam. In this instance, it a parked AEP truck prohibited access to the lake.

In addition to the measures in Table 1, there was a massive input of debris (Figures 1-3). The problem was so severe that it impacted recreational access to the lake and clearly presented a safety hazard to personnel and property. Strategies need to be implemented by AEP and partners to deal with issues of water quality and debris.

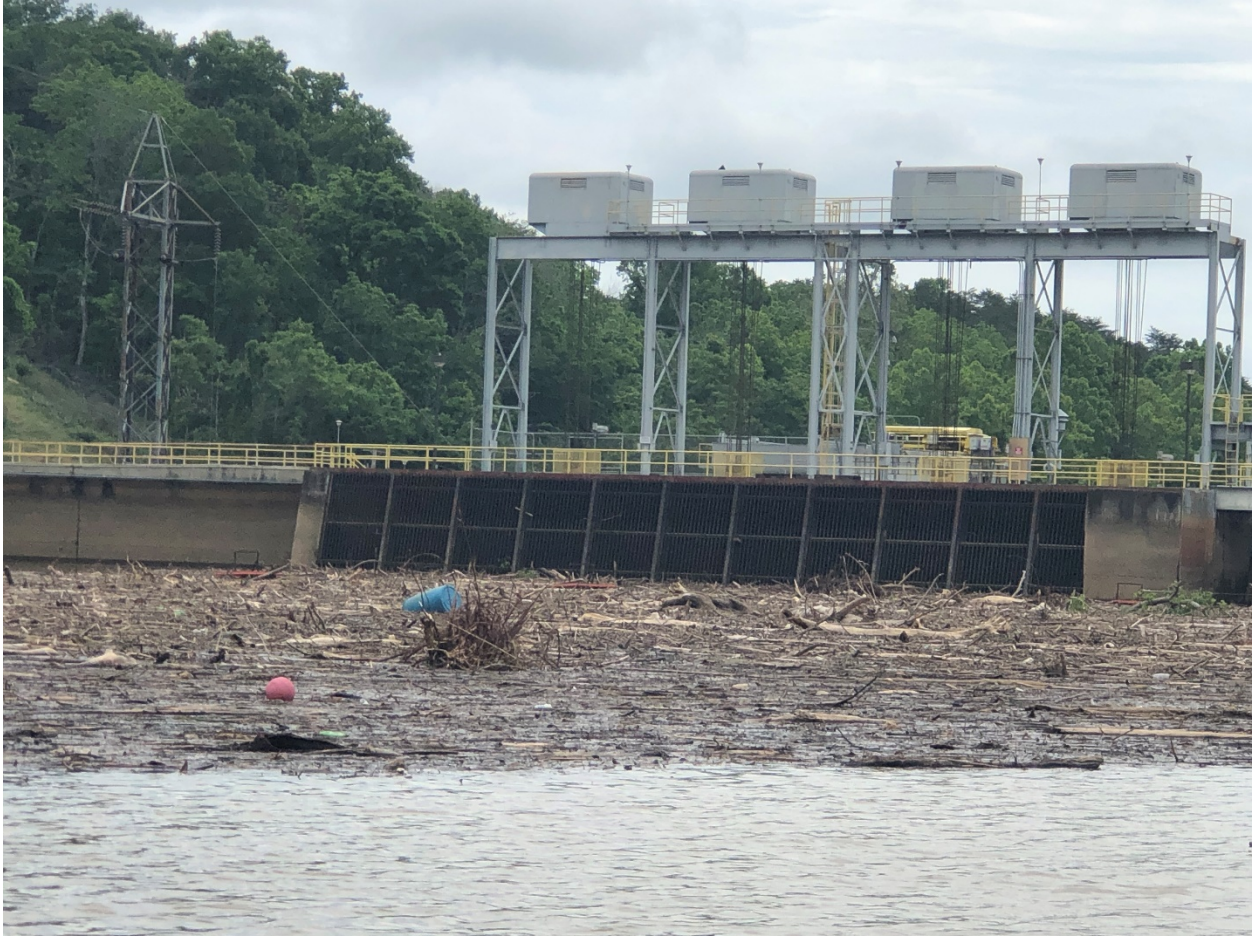
The extent and amount of debris that had accumulated at the dam was remarkable (Figure 2). A crew from AEP was actively working to move the debris to the shore with a pontoon boat and then removing it from the lake with a trackhoe. With the exception of events immediately after destruction of the Pigg River Power Dam, debris of this magnitude has not been observed. Contrast this photo with Figure 3. This is similar to the buildup of debris at the bridge on Power Dam Road in Rocky Mount Va. It seems clear debris is entering the Pigg River from sources in the watershed and then traveling down river and into Leesville Lake.

Figure 2 – Buildup of debris at Leesville Lake dam due to heavy rains throughout the area.

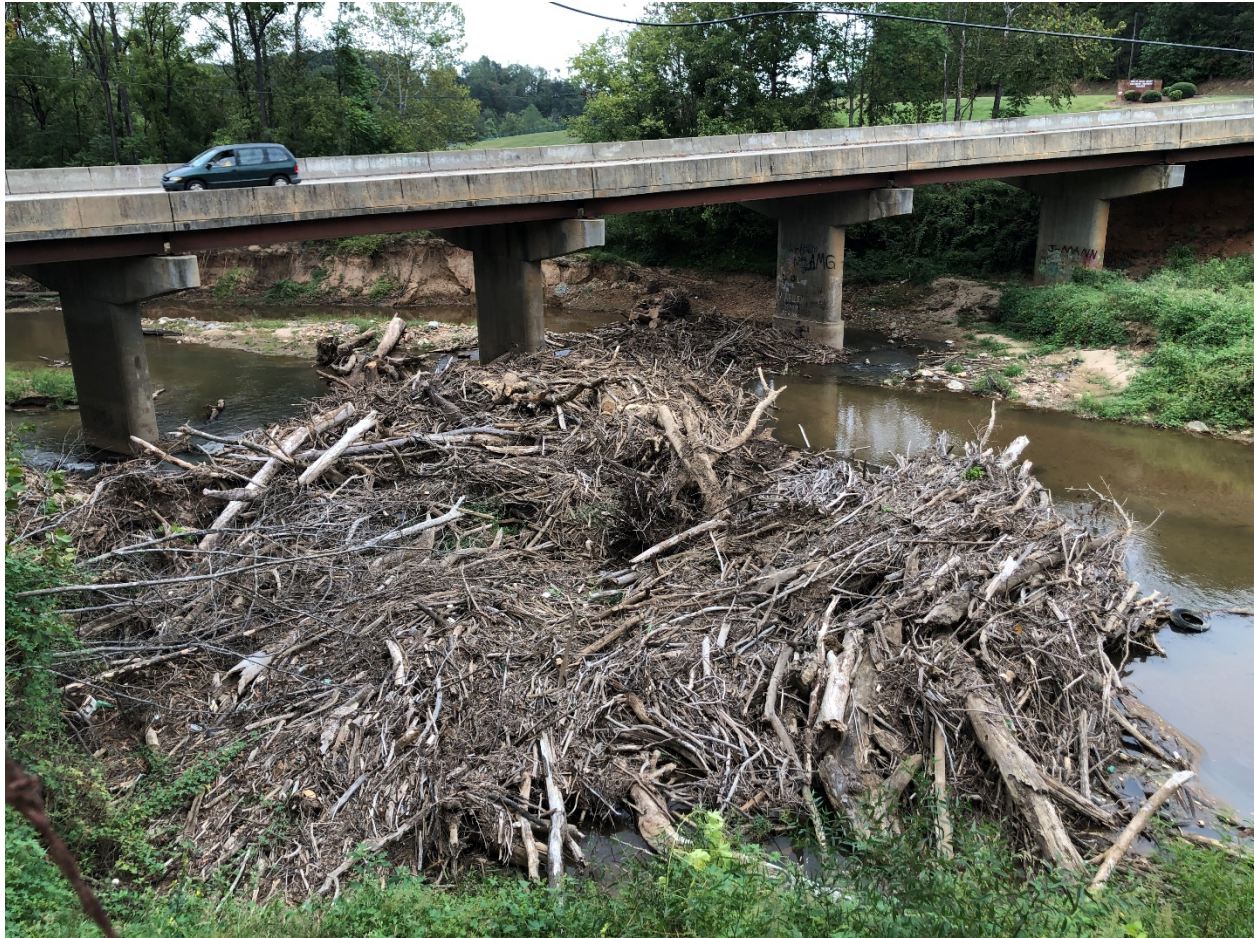
Figure 3 – Debris buildup at the bridge on Power Dam Road in Rocky Mount Va. Photo taken September 18, 2019.

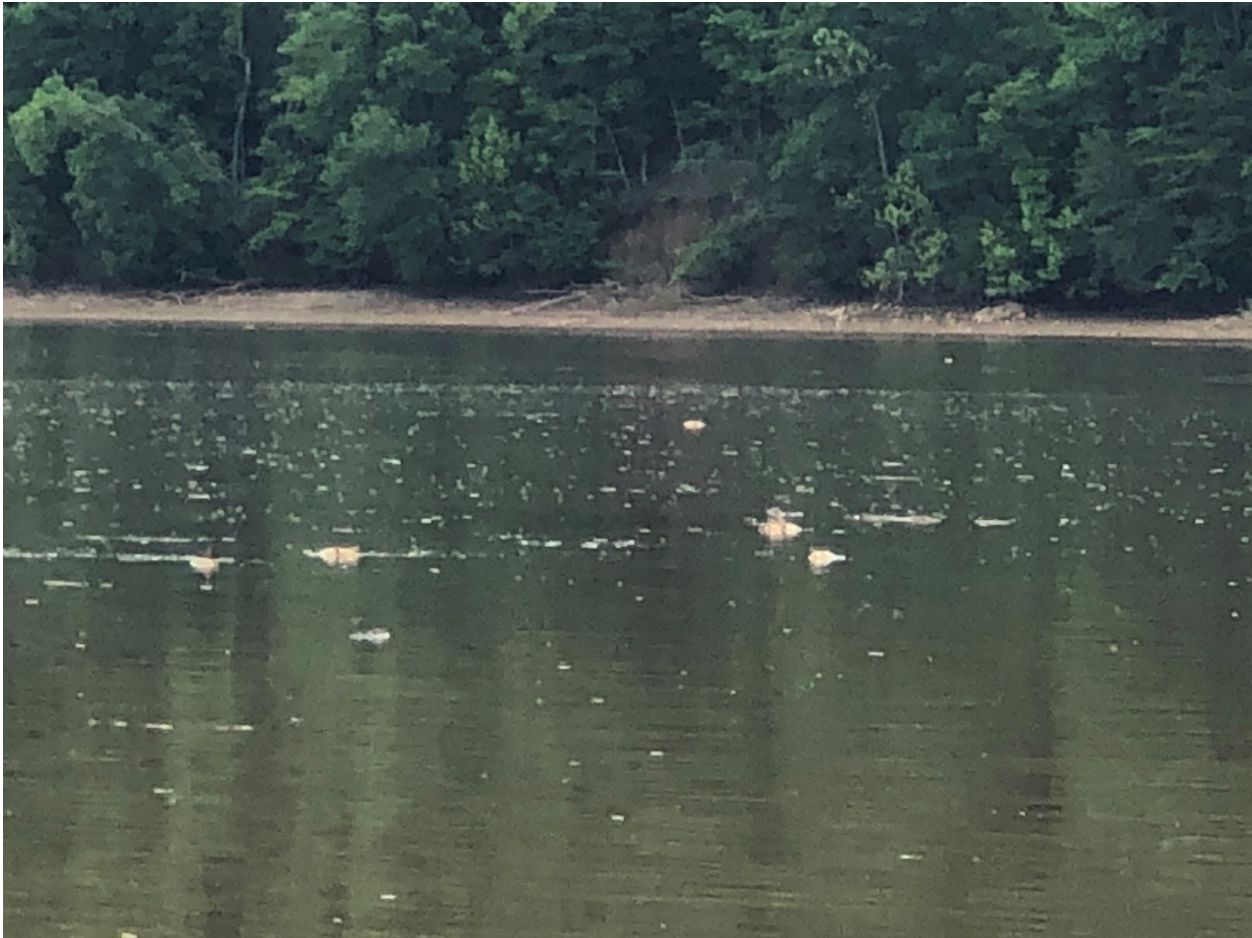
Traveling up lake the water quality continued to degrade. Near MM9, I began to observe a fish kill (Figure 4). We estimated over 30+ fish (mostly carp) throughout the lake from MM9 and up into areas near and into SML tail waters.

Figure 4 – floating dead fish near Mile Marker 9 in Leesville Lake.

Secondarily, the fish kill observed is concerning to those on the lake. The vast majority of fish were carp and several factors that may have contributed to their death. According to the Department of Environmental Quality and the Department of Games in Inland Fisheries (DGIF), this event is not uncommon in waters of Virginia during the spring and appears to be caused by a carp disease supplemented with spawning stress. Notably, an outbreak occurred on the Blackwater tributary in 2017. Additional stress may have been imposed by the presence of large amounts of sediment in the water, which can impair gill function. Suspended sediment is known to have deleterious impacts on fish

and in particular carp (Xu et al. 2018). The majority of the fish observed were in the upper reaches of the reservoir where sediment concentration are highest.

Finally, the very high water level in Smith Mountain Lake, which caused water overflow into the spillway may have caused injury to fish that were carried over the dam. Algera et al. (2020) document injury and fish mortality may occur during fish passage through hydroelectric dams; however, such fish kills have not been noted during other periods of power generation and turbine function. What was novel was that the high water level of Smith Mountain Lake resulted in passage of water (and fish) via the spillway. This may have caused significant fish mortality.

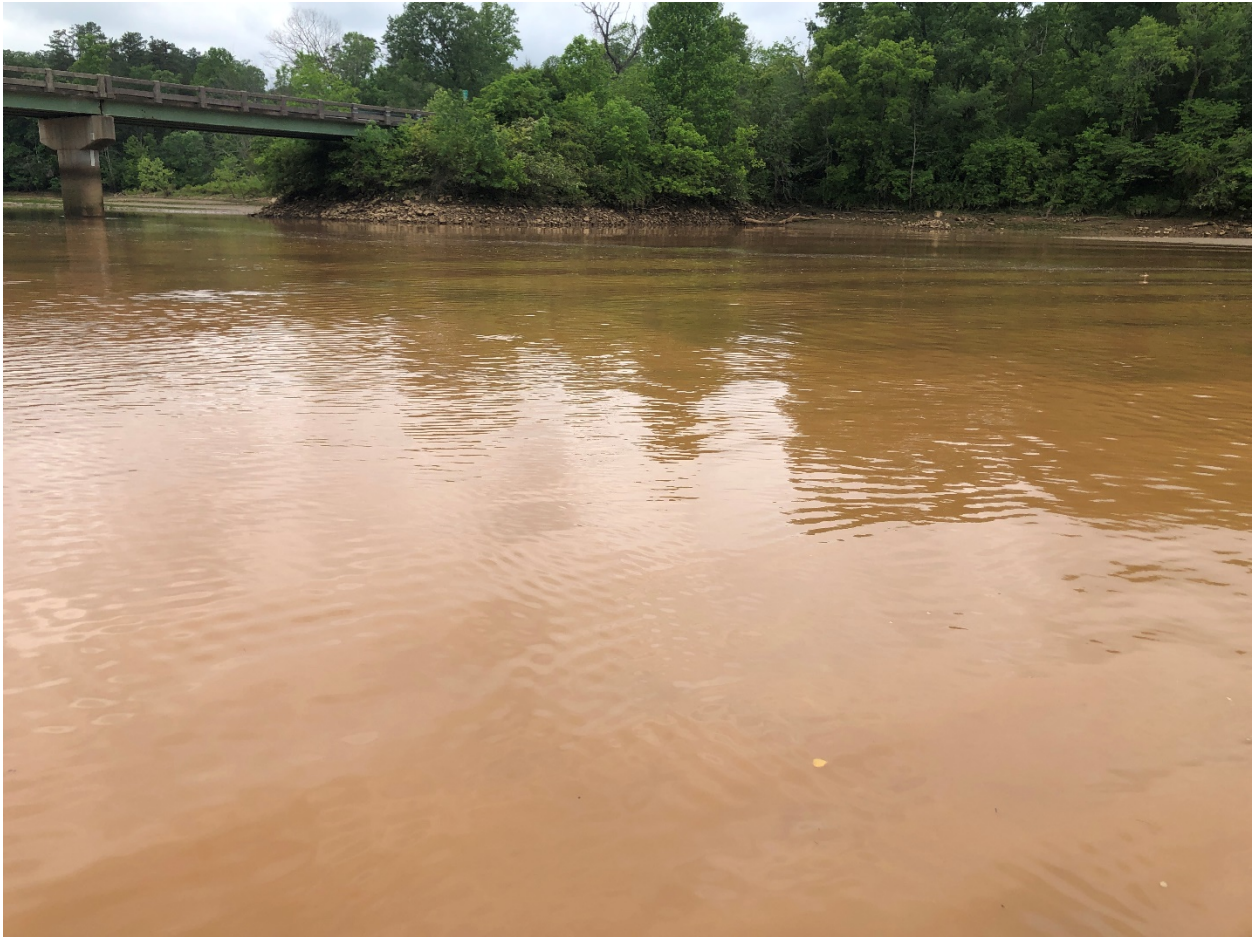
Near Toler Bridge several observations were made. The water was extremely turbid (Figure 5). While turbidity is often observed at this location after rain events, this turbidity was very strong in color Smith Mountain Lake was discharging during the sampling event and a clear turbidity demarcation between Pigg River water Smith Mountain Lake water was apparent near the mouth of the Pigg River (Figure 6). But water from Pigg River very rapidly fanned out across the lake at Toler Bridge causing brown turbid water downstream throughout the entire lake.

Figure 5 – Water quality observations at Toler Bridge on May 29, 2020.

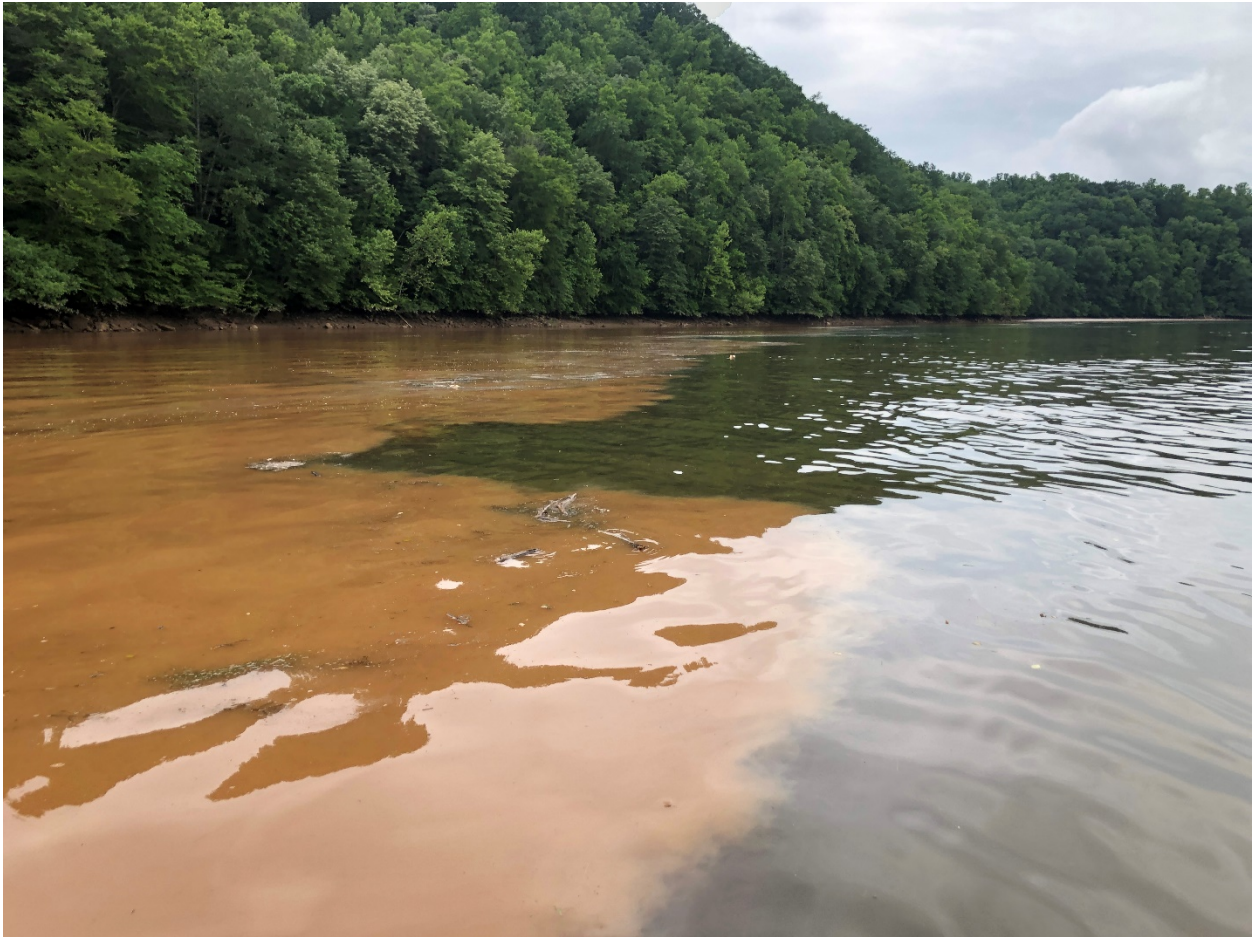
The contrast between water flowing from the mouth of Pigg River into Leesville Lake and tail waters of Smith Mountain Lake was very strong (Figure 6). While this pattern has been observed previously, the thick contrast between Pigg River and SML tail water was severe.

Figure 6 – water contrast between water flowing from Pigg River and tail water release from SML.

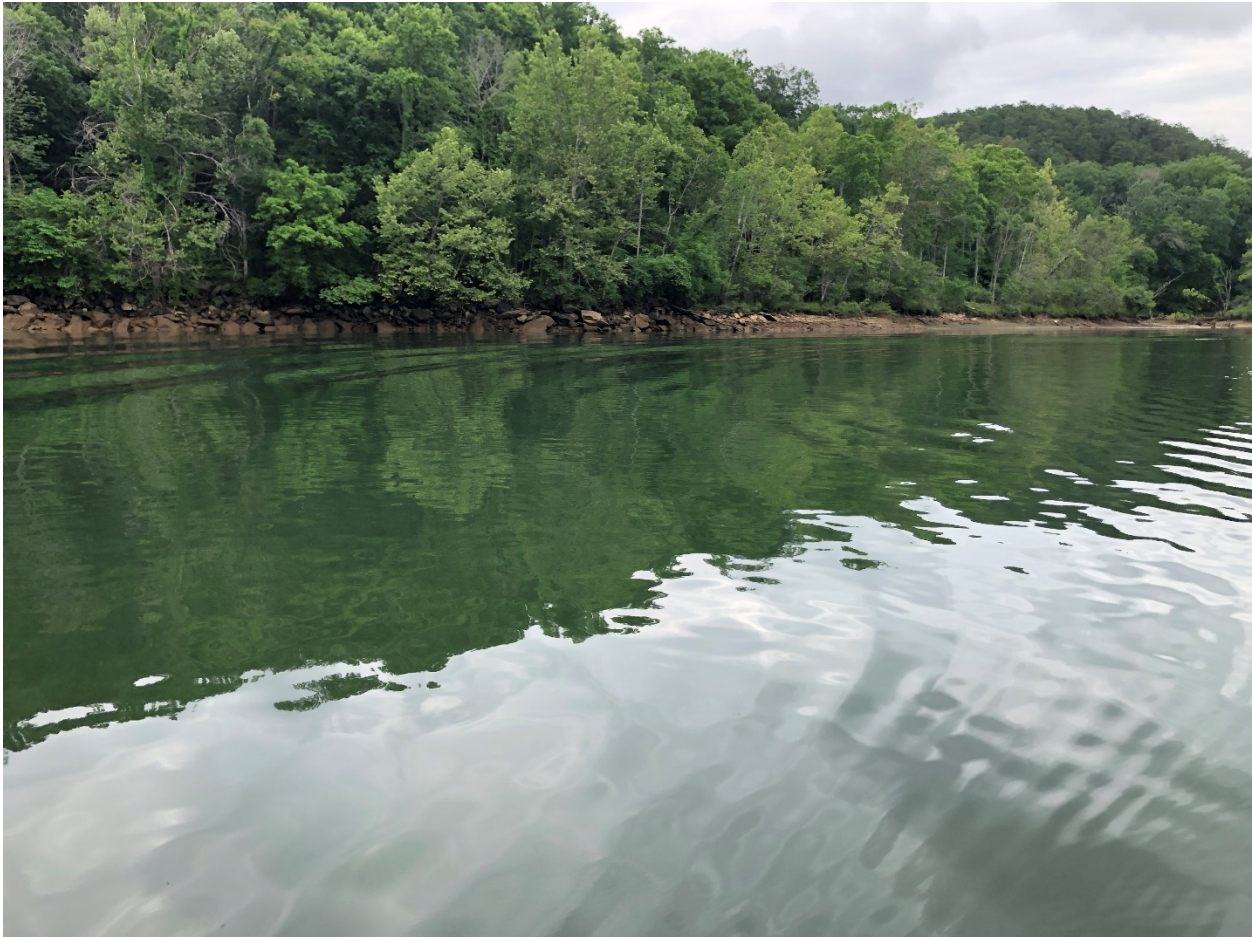
Finally, water quality observed at the tail water section of the reservoir was in stark contrast to the remainder of the reservoir (Figure 7). For example, Secchi depth (a measure of water visibility) of water in Pigg River was 0.2 meters while a similar measure at tail waters was 2.8 meters. The contrast could not be more severe. During this sampling day, water quality suggests that the lake water reflected that of two different reservoirs. We did additionally note dead fish in the tail water section.

Figure 7 – tail water portion of Leesville Lake May 29, 2020.
